SURVEYOR III PARTS AND MATERIALS/EVALUATION OF LUNAR EFFECTS

RETURNED FROM THE MOON BY APOLLO XII

SUBMITTED 22 JANUARY 1971

P 70-54
(SSD 00628R)

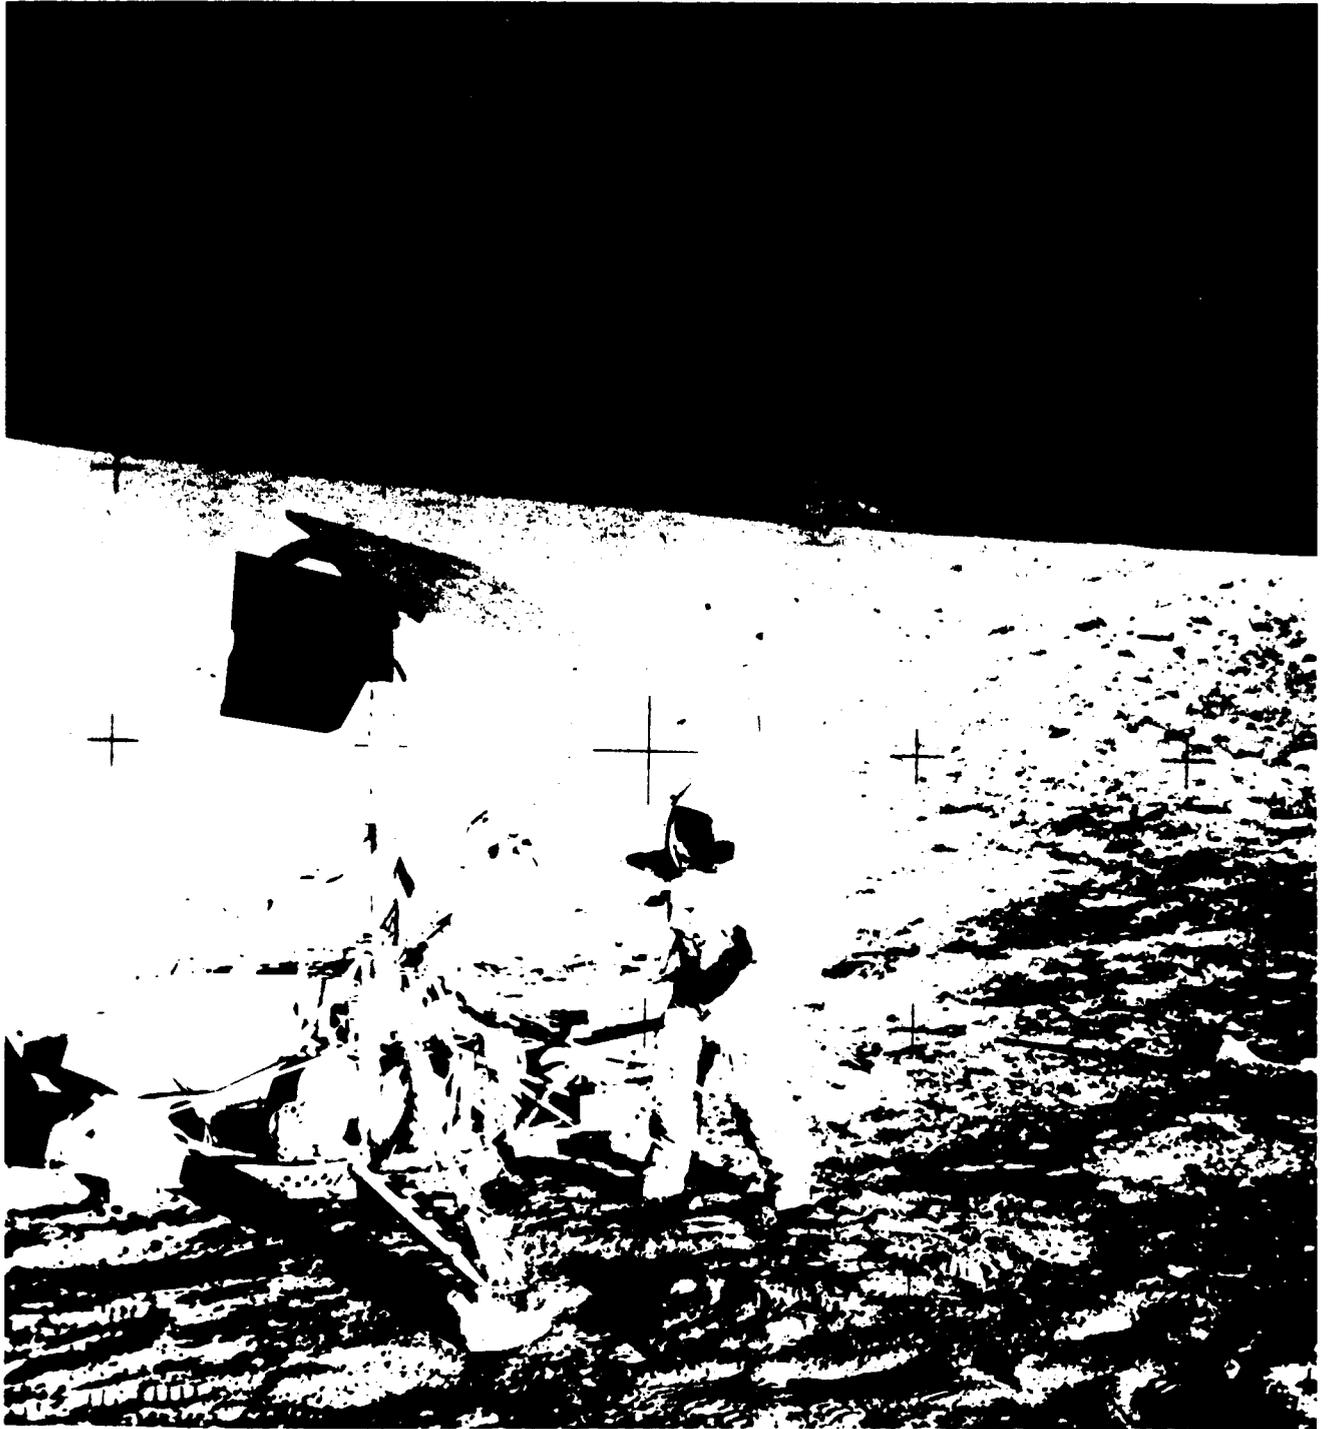
Figure 3-2. Retrieval of Surveyor III Parts, Showing SM/SS in Raised Position (NASA Photo AS-12-48-7133)

After completion of the soil mechanics experiment on the lunar surface, the scoop was left in the raised, fully extended position (Figure 3-2). Before it was removed from the spacecraft, one of the astronauts manually pushed the scoop in toward the spacecraft without encountering difficulty; this indicated that significant cold welding had not occurred in the joints. The joints and bearing surfaces had been lubricated with MoS₂ compounds. When released by the astronauts, the scoop reextended itself easily, thereby indicating that the springs were still working well.

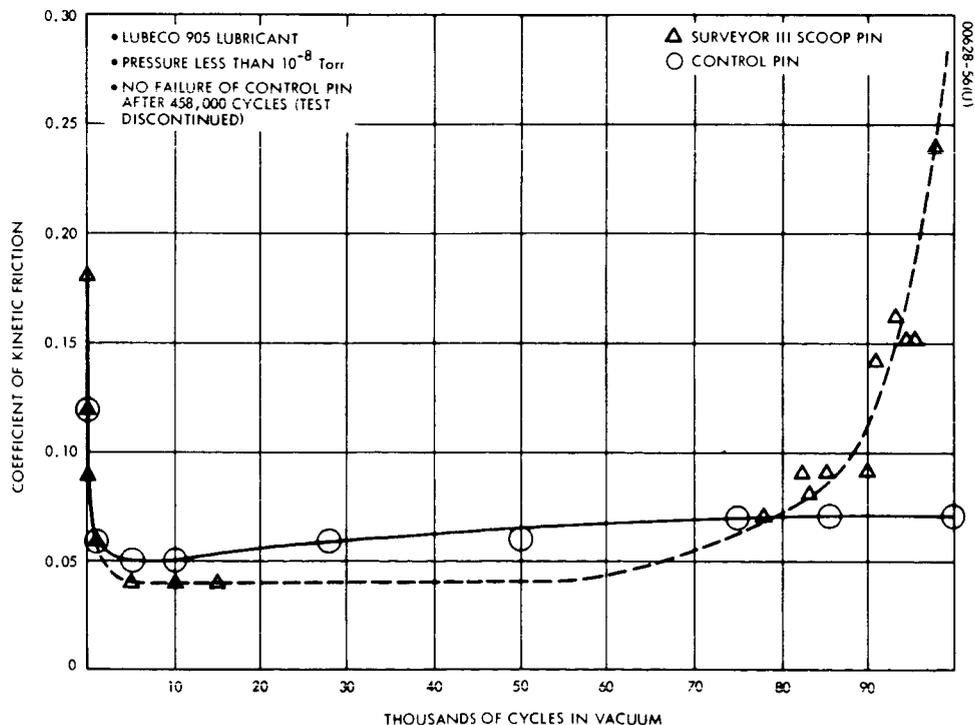
The lubricant coating on the Surveyor III pin failed after approximately 100,000 cycles. The test on the control pin was terminated after 458,000 cycles; no sign of failure had occurred up to that point. It is estimated that the control coating would have withstood about twice this number of cycles.

The steady-state friction of the lubricated pin from the Surveyor III scoop was lower than that of the control pin. The explanation of this phenomenon lies in the previous histories of these coatings. The Surveyor III pin had been operated prior to launch for an unknown number of cycles under loads of 240 psi. The pin then experienced several hundred cycles of operation on the moon.

Figure 4-14. Friction Test in Vacuum of Surveyor III Scoop Pin and Control Pin

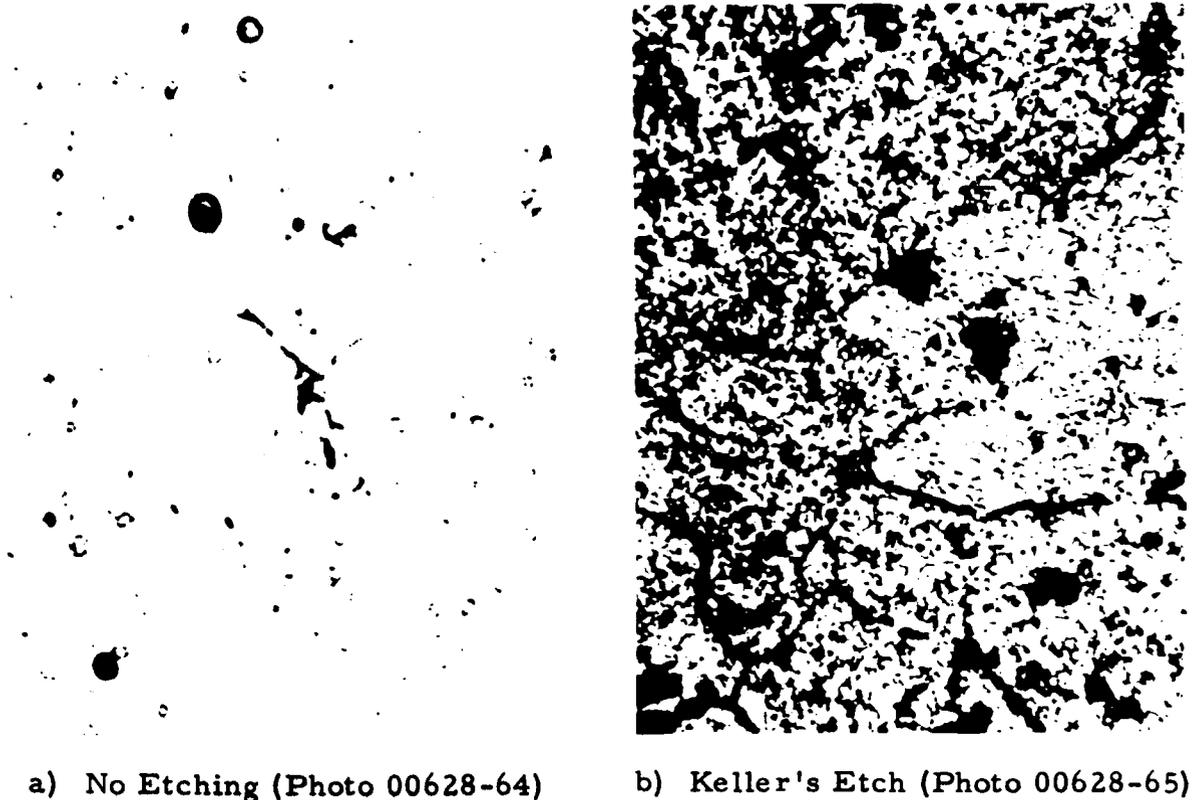
Figure 4-19. Microstructure of Polished Aluminum Tube From Surveyor III (1000X Magnification)

The grain boundaries in the microstructure prior to etching can be seen in Figure 4-19a. Figure 4-19b shows that this microstructure was attacked abnormally upon a very light application of the etchant. The sample was not repolished after etching and is available for further tests. The normal microstructure of the 2024-T3 control sample is shown in Figure 4-20. No grain boundaries are visible in this control sample in the unetched condition in Figure 4-20a. The grain boundaries become evident in the control sample after etching in Figure 4-20b. However, the general structure is not attacked as severely as that of the Surveyor III polished tube section shown in Figure 4-19b.

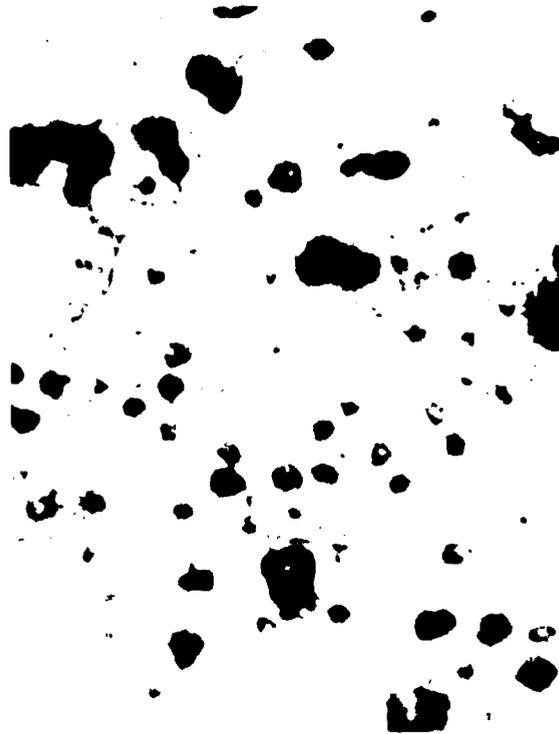
The unedged microstructure of a longitudinal section of the painted tube was similar to that taken of the control sample shown in Figure 4-20a. The microstructure of the painted tube after etching is shown in Figure 4-21. The appearance is normal and similar to that of the etched control sample shown in Figure 4-20b. The grains are more elongated in Figure 4-21 due to the sample orientation.

Figure 4-21. Microstructure of Painted Aluminum Tube From Surveyor III (1000X Magnification)

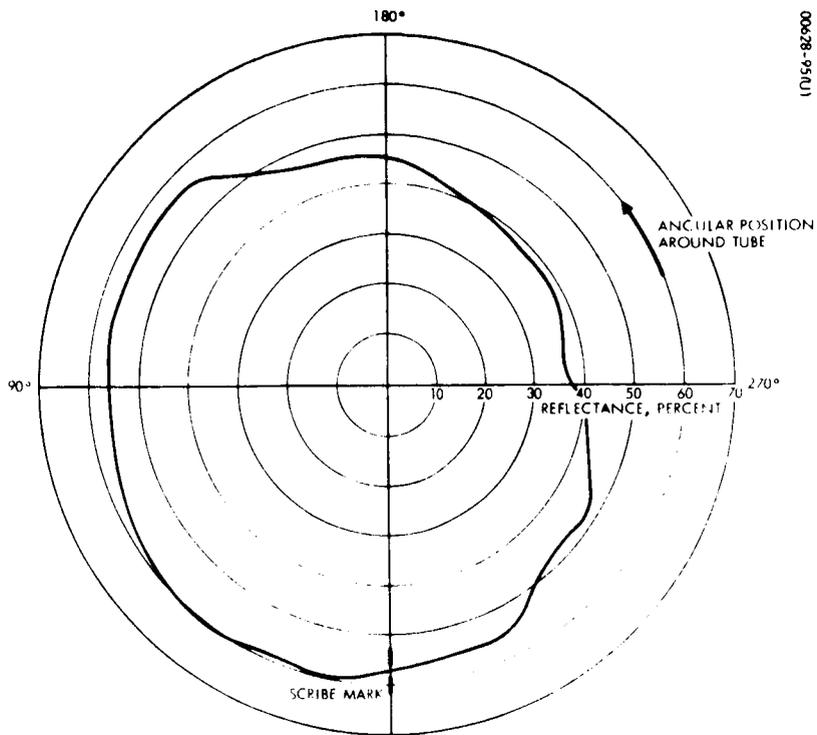
a) SECTION A, LUNAR CUT END UP

The tube was cut into several sections, as described in Appendix A. Reflectance measurements were obtained on sections A and G, which had been made available to Hughes. The contamination on the tube was on only one side of the tube and heavier on section G than on section A. As concluded in Section 4.6, the contaminated side of this tube pointed inboard toward the spacecraft and down about 45 degrees from the horizontal. Section G came from the end of the tube closest to the spacecraft radar antenna.

The extent of contamination along the length of each tube section was determined by measuring the reflectance along the contaminated side. These measurements were made by placing each tube section vertically in a Gier-Dunkle integrating sphere. Separate reflectance measurements were made every 1/4 inch along the tube at a single wavelength of 0.47 micron. The reflectance at the circumferential position of heaviest contamination of section G was found to be about 11 to 13 percent. Along section A, the reflectance was measured to be about 38 percent. No axial gradient was found on either section of tube.

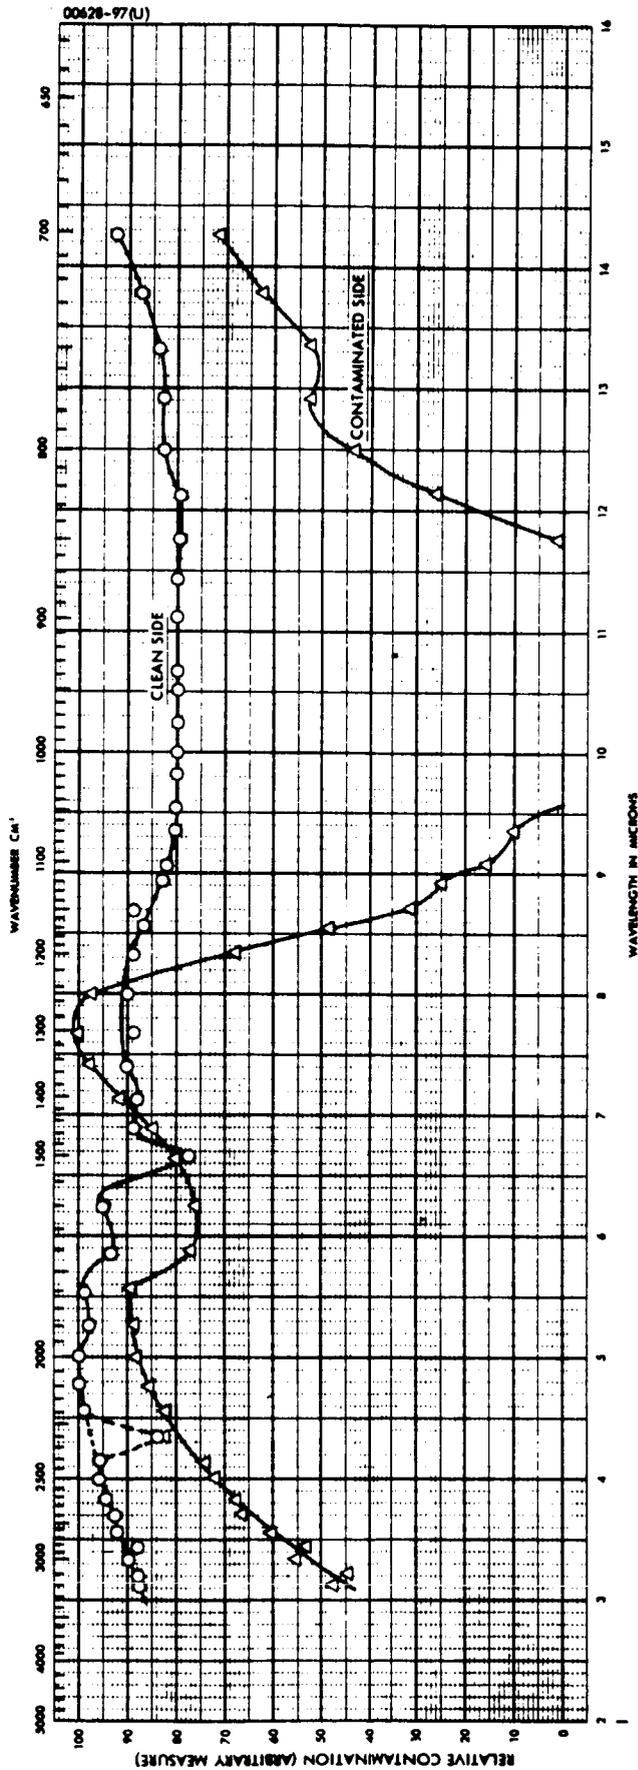
Figure 4-33. Infrared Reflectance Spectra of Contaminated and Clean Sides of Section G of Polished Aluminum Tube

Data from the two spectra were compared; a plot of the resultant data for the contaminant is given in Figure 4-33. No evidence of organic bands is seen in the figure. It should be noted that the experimental techniques used may have reduced the sensitivity to the presence of organics. While no definite conclusions can be drawn regarding presence of some organics, results strongly suggest that the heavy contamination was not dominantly organic in nature, such as resulting from significant outgassing of organic materials on the spacecraft.

A small amount of dust that had previously fallen from the SM/SS scoop was placed on aluminum foil, and its infrared spectrum was obtained using the ATR. This spectrum is shown in Figure 4-34. Comparison of the two spectra of Figures 4-33 and 4-34 indicates that the contaminant is probably lunar material.

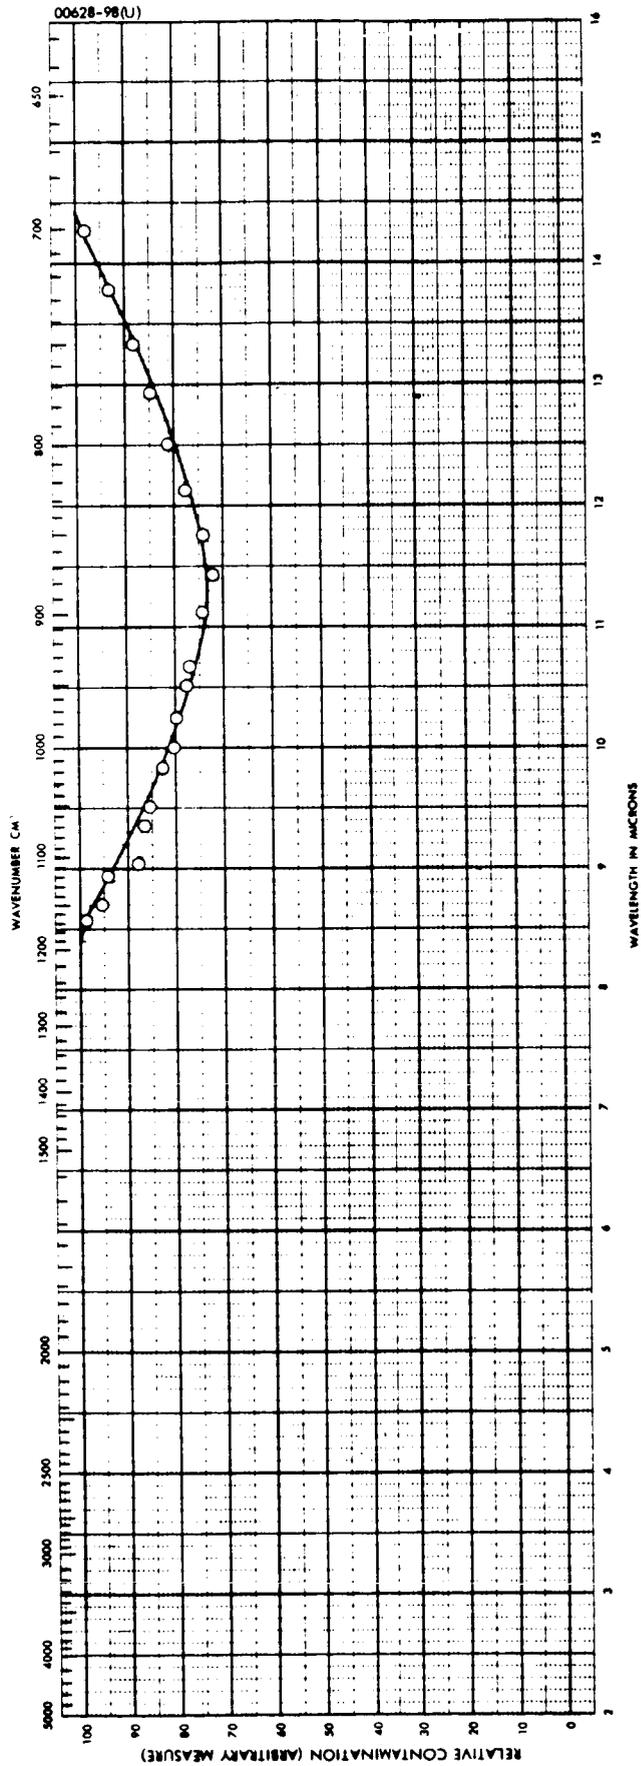
Figure 4-34. Infrared Reflectance Spectrum of Lunar Dirt
From SM/SS Scoop

The high count for aluminum indicated in Table 4-24 is due to the base material. The other high readings - titanium, magnesium, iron, calcium, and silicon - are characteristic of the lunar material. The above results were compared with the analysis of lunar material returned by Apollo XII (Reference 9) and Apollo XI (Reference 10). Results of this analysis indicate that the brownish contamination on the polished aluminum tube was lunar in origin.

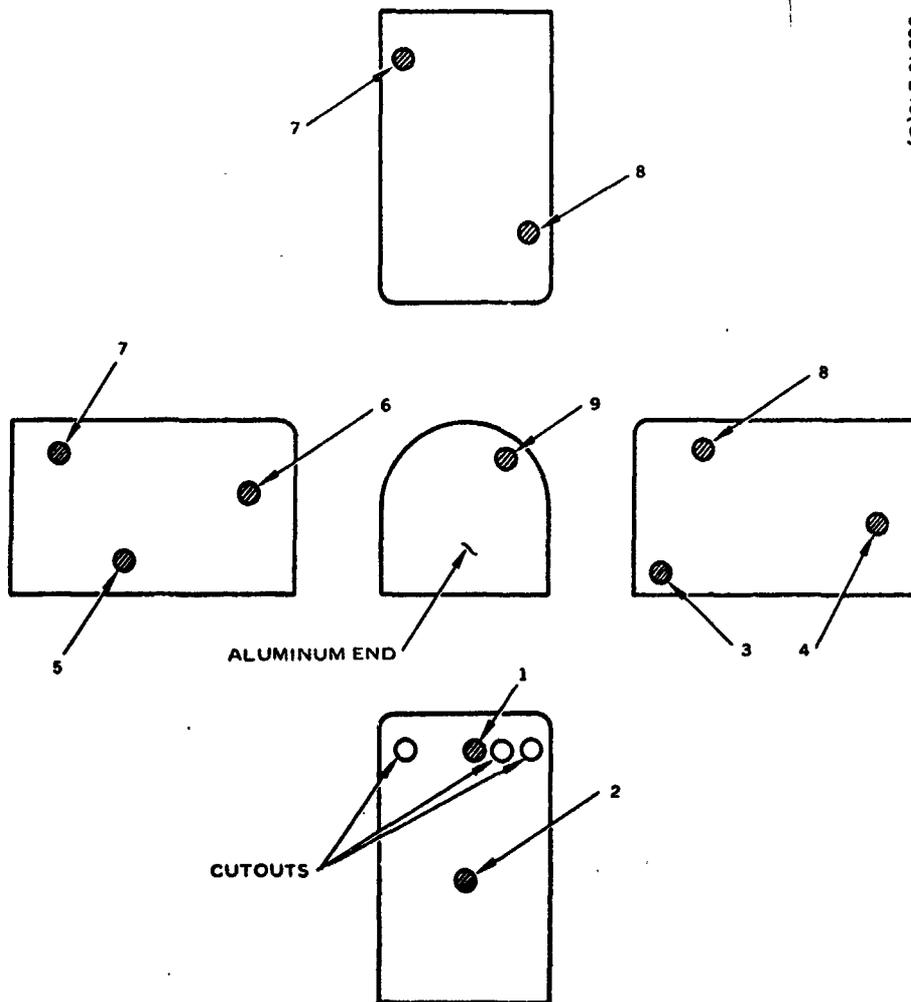
Figure 11-1. Lower Shroud of Surveyor III Camera, Showing TRW Measurement Positions

The reflectance of the lower shroud of the television camera was measured at seven locations (Figure 11-1). Throughout this subsection, these numbered positions are referred to as "TRW positions". Positions 5, 6, and 7 were on the side of the shroud facing the landing site of the lunar module. Positions 1 and 2 corresponded to the front of the shroud, which faced the lunar northeast.

A decrease in reflectance over original values at 1.5 microns was found on most surfaces. This was not seen on TRW position 1 of Figure 11-1. This location was protected from the lunar environment by a bracket, whose photographs are shown in Appendix J (Figures J-19 and J-20). Laboratory studies have shown that neither ultraviolet nor solar wind protons will cause a reflectance decrease at 1.5 microns for this clay-silicate inorganic paint. Thus, the reflectance drop is attributed to lunar dust. Organic contaminants were ruled out as discussed later. The variance in the magnitude of the reflectance at 1.5 microns is a measure of the amount of lunar material present on the surface. Table 11-1 summarizes the significant results obtained. An expression relating dust coverage to the reflectance is presented in Section 11.4.2.

With the exception of one small area designated in Figure 11-1 as TRW position 3, described below, all exposed surfaces of the camera had a coating of fine lunar material. The amount of this coating varied from area to area: the "dirtiest" area was estimated to be about four to five times more heavily coated than the "cleanest" area. The various sources of lunar dust are listed in Table 11-5. These variations in the degree of cleanliness may thus be attributed to the quantity of dust imparted from the various sources to the differences in the adhesion of the dust to camera surfaces and to the various mechanisms of removal of the dust: prior to camera retrieval, during return, and during subsequent handling. In addition, there was some variation in surface roughness of the paint; the rougher areas tended to hold more material during deposition and during disturbances in handling.

A small area on the side away from LM, designated as TRW position 3 in Figure 11-1, appeared to be free of dust. This area was beneath the cable running from the front, along the left side of the camera. * The absence of dust may be due to "shadowing" of the surface from the incident dust or caused by a removal mechanism not fully understood.

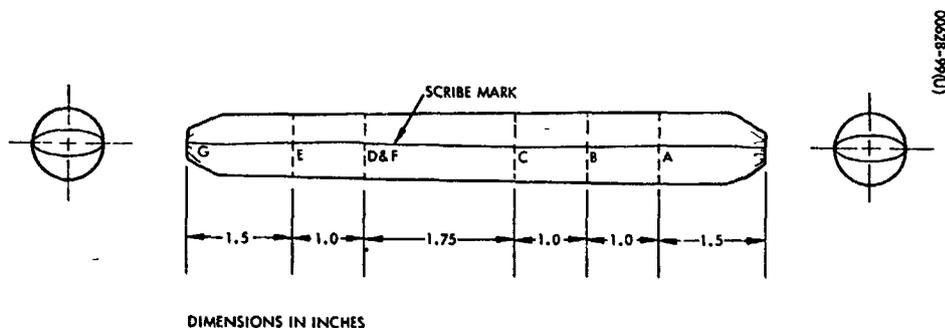
Figure A-1. Sectioning Arrangement for Polished Aluminum Tube

The polished tube is sketched in Figure A-1, which indicates the identifying scribe lines and the lettered segments subsequently sectioned. The tube ends were pinched during the lunar cutting operations into oval or pear shapes, as described in Section 4.5.2. Two scribe lines were made on the tube close to each other, one light and one heavy, from apex to apex. Only one of these lines is indicated in the figure. The two scribe lines cross each other several times; in some places, they were separated by as much as 1/16 inch.

The six sections into which the tube was then sectioned and the identifying letters for each section marked on the polished tube prior to sectioning are shown in Figure A-1. The lengths of each section are also indicated. Figure A-2* is a photograph of the tube after the identifying marks were made and prior to its sectioning.

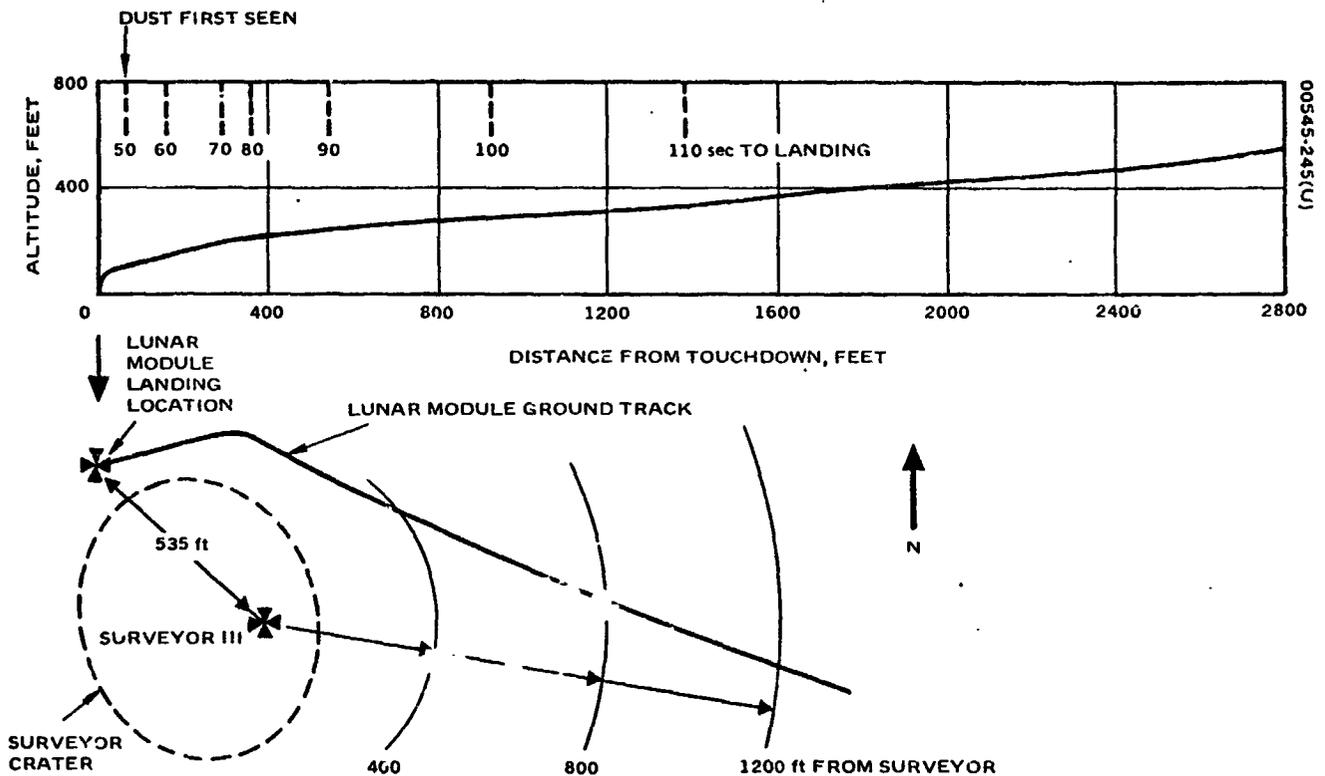
Figure J-4. Approach and Landing Configuration of Lunar Module Relative to Surveyor III

The Apollo XII terminal descent is described in detail in Reference 107 and summarized in Figure J-4. The Apollo landing site was approximately 535 feet northwest of the Surveyor spacecraft.

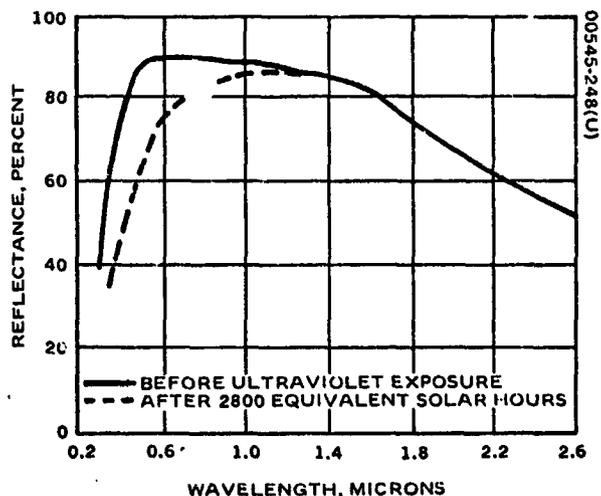
Figure J-8. Spectral Reflectance of White Inorganic Paint Before and After Laboratory Ultraviolet Exposure

The spectral character of the damage in the Surveyor inorganic white paint is illustrated in Figure J-8.

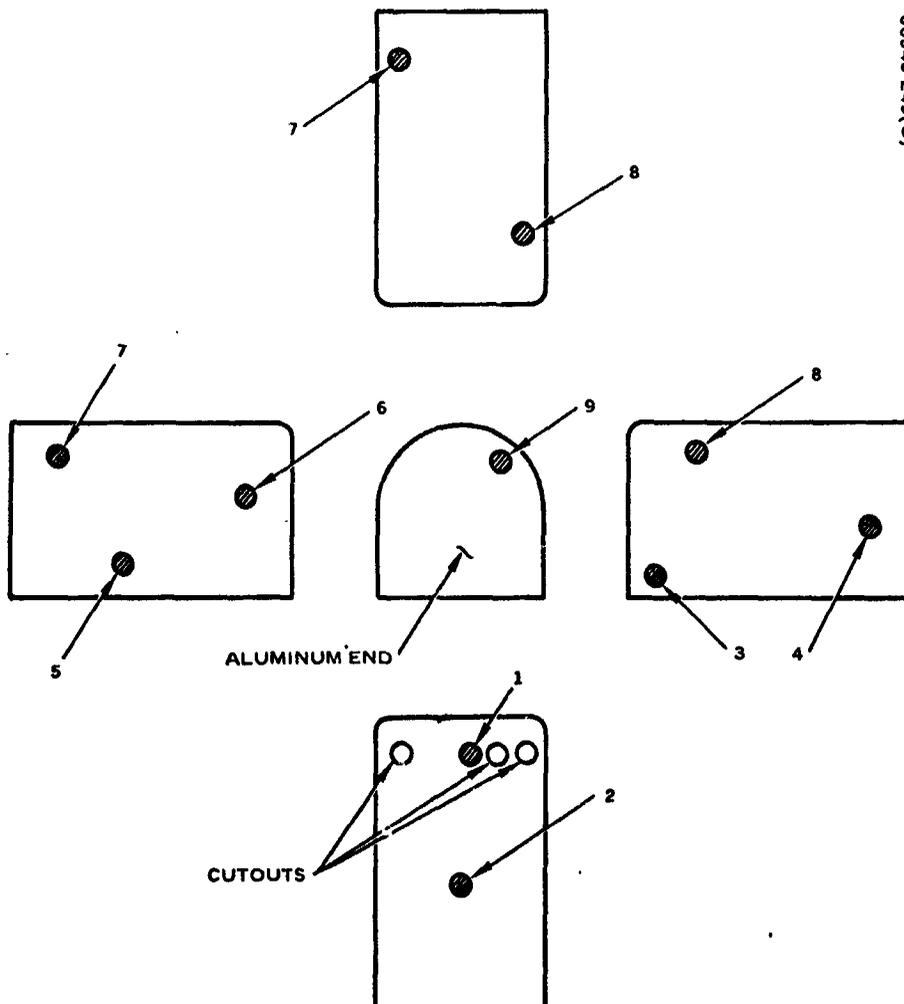
Figure J-9. Lower Shroud of Surveyor III Camera, Showing TRW Measurement Positions (See Text)

This set of measurements was made by TRW at a number of positions on the lower shroud, using a wall-mount integrating sphere. The positions of each measurement are sketched on Figure J-9. Figure J-10 presents spectral plots of these measurements. Table J-1 shows the emittance of each position as measured using a Gier-Dunkle emittance inspection device, model DB-100.

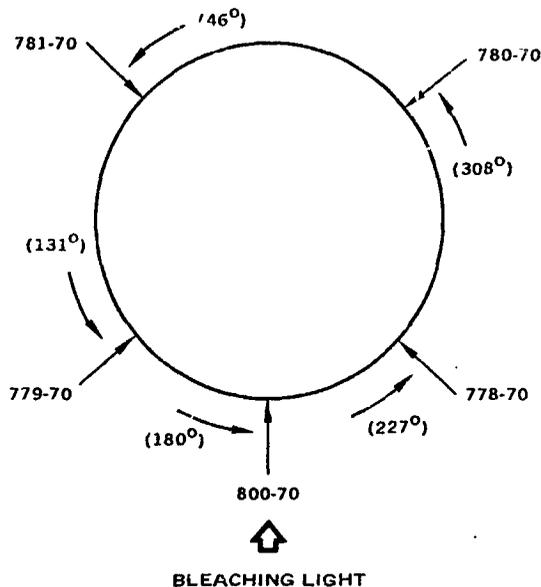
Figure J-12. Sketch of White Painted Section of Tube Returned in SESC Showing Measurement Positions

The spectral reflectance of the tube was measured around the circumference at 90 degree increments, while the sample was maintained at 5×10^{-7} Torr. The measurements were made by positioning the quartz chamber in an Edwards integrating sphere. Room lights were off during these operations; only dim red light was used to position the sample. It was not possible to rotate the quartz chamber so that each measurement would be made in the same plane. The chamber was raised and lowered so that about 0.63 inch separated the uppermost and lowest measurement. Figure J-12 is a sketch of the tube showing measurement orientation.

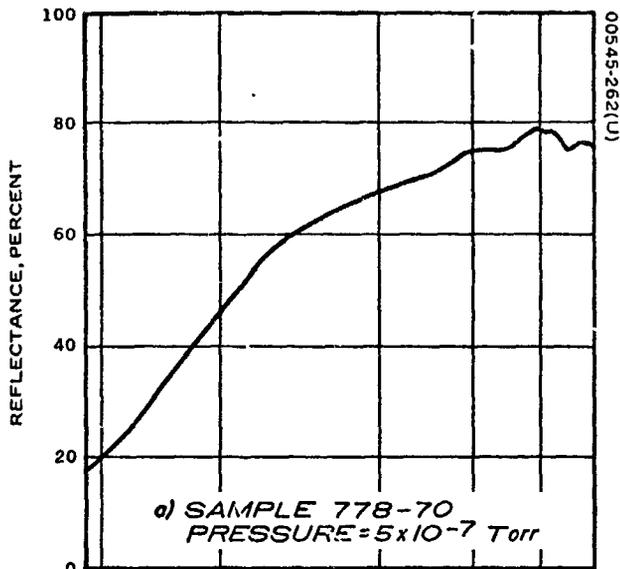
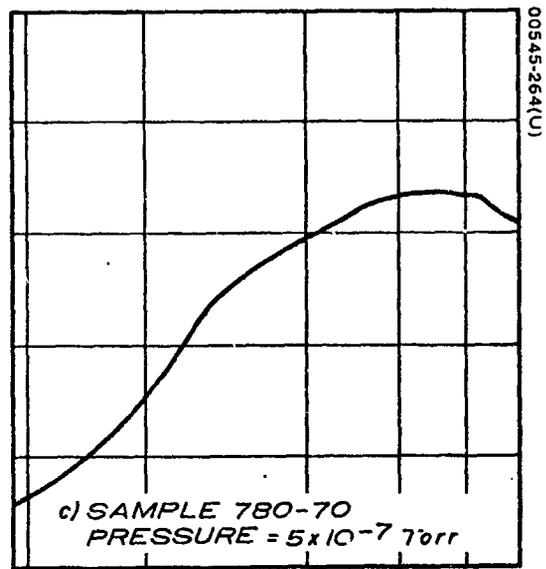
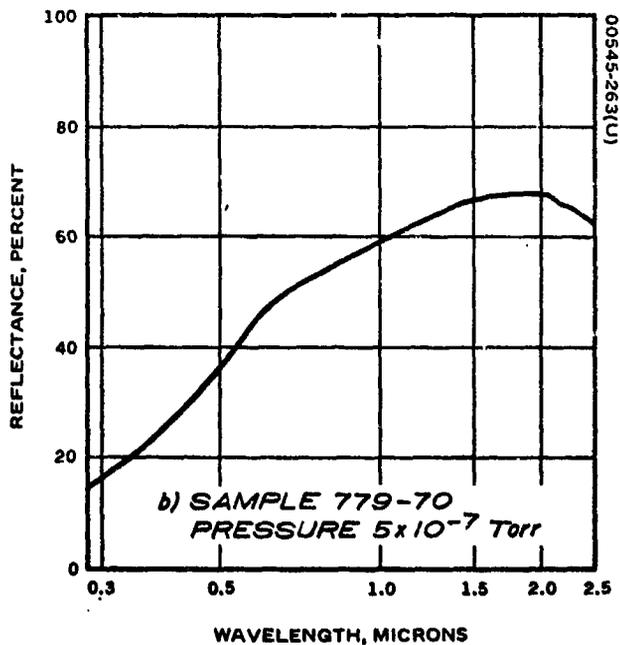
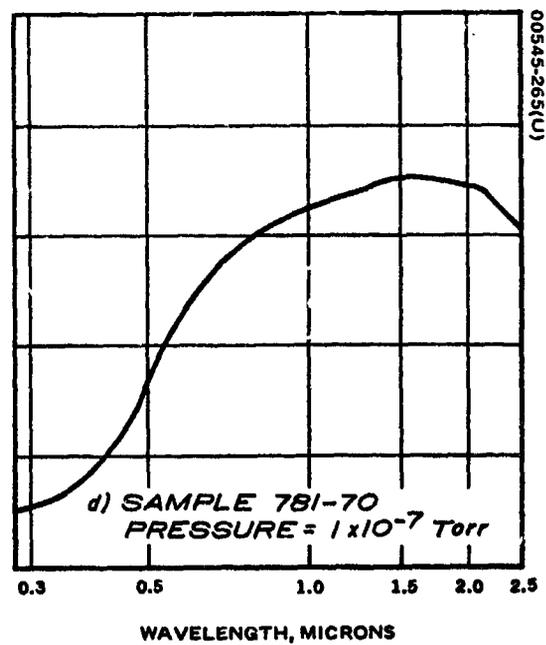
Results of the measurements of the spectral reflectance of the white painted tube, discussed above, are presented in Figures J-13 through J-18. Figure J-13 shows the reflectance versus wave length of the four samples measured in vacuum prior to exposure. Figure J-14 shows the reflectance after partial pressurization at relatively low pressures. Figure J-15 shows reflectance of the four samples after they were exposed to 1 atm, still prior to any light exposure. Figure J-16 shows the reflectance of one of the samples after 6 days exposure at 1 atm. Figure J-17 shows reflectance of another sample from a different portion of Figure J-12 taken after an exposure to light for 48 hours at 1 atm. Figure J-18 shows reflectance of the original four samples at 1 atm after they had been exposed to 48 hours of light.

Figure J-13. Spectral Reflectance Versus Wavelength of Four Samples of White Painted Tube - High Vacuum, Prior to Light Exposure

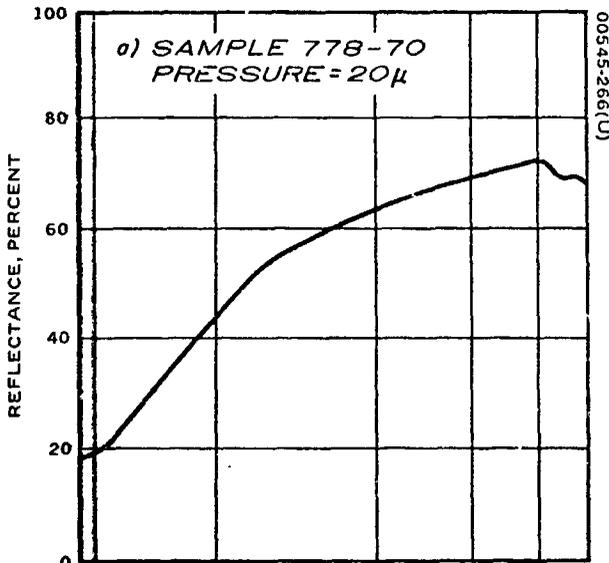
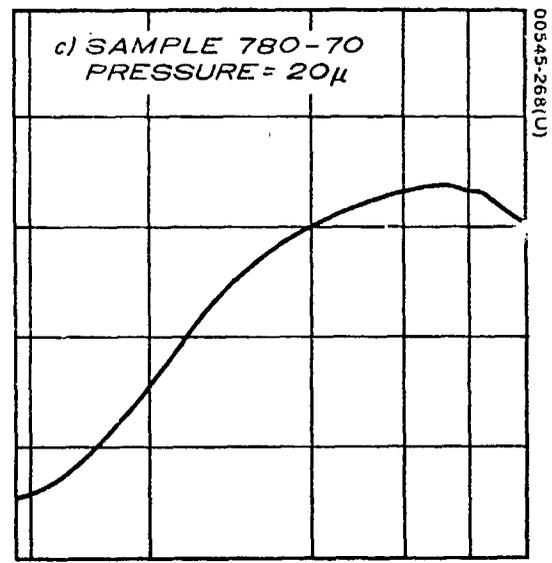
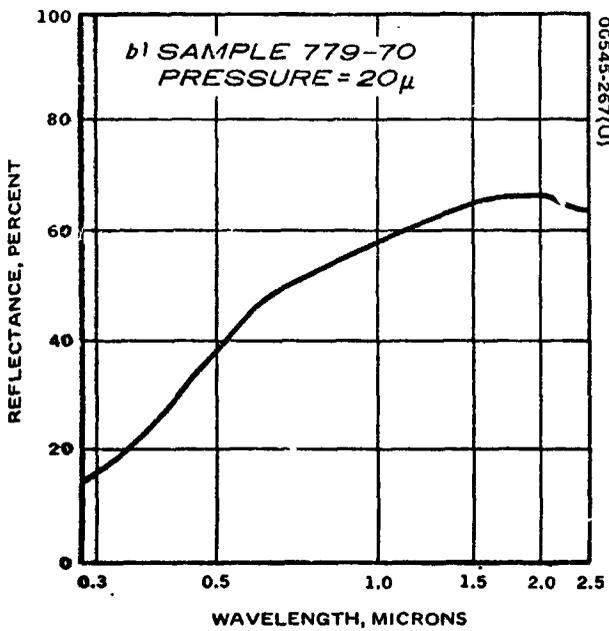
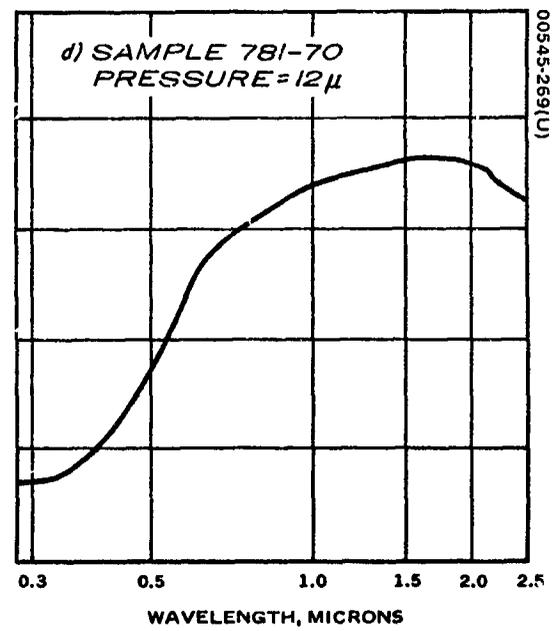
Figure J-14. Spectral Reflectance Versus Wavelength of Four Samples of White Painted Tube - Medium Vacuum, Prior to Light Exposure

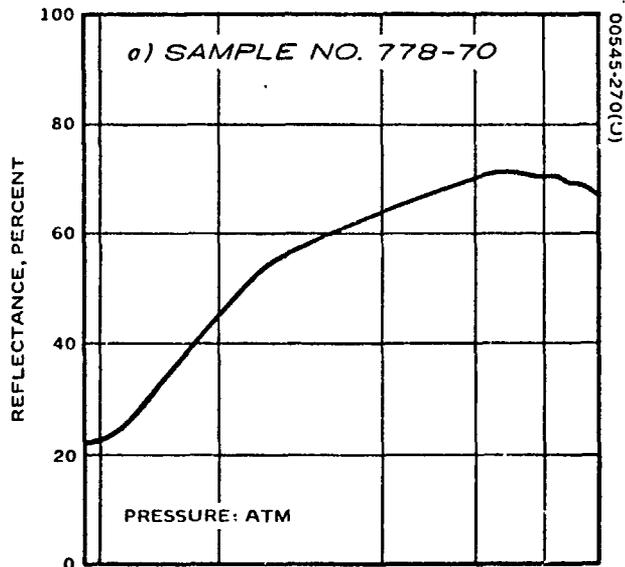
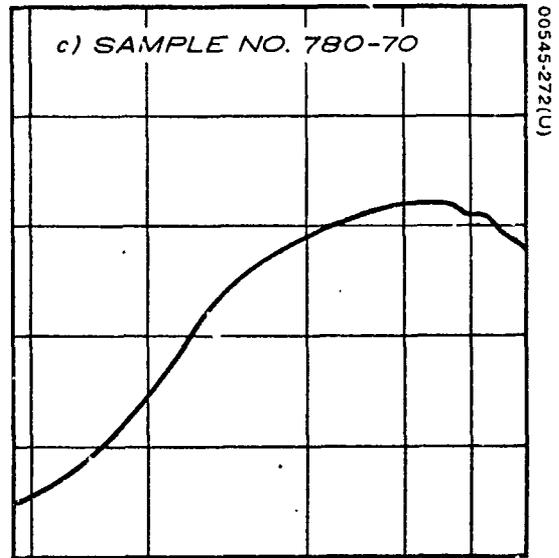
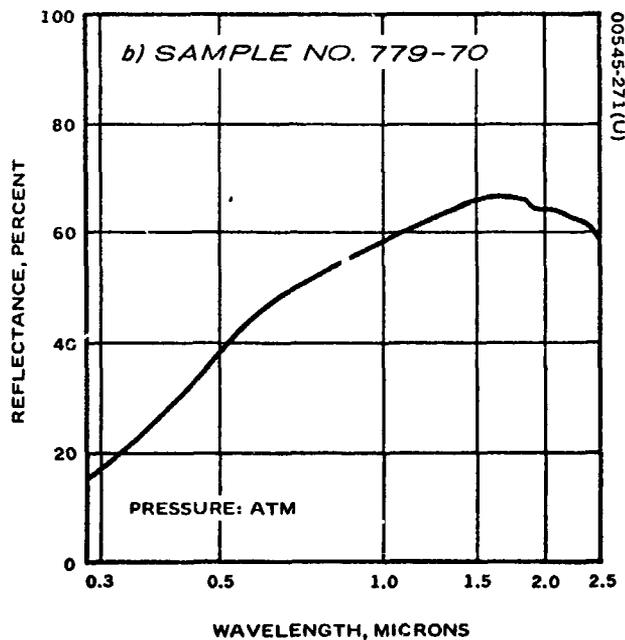
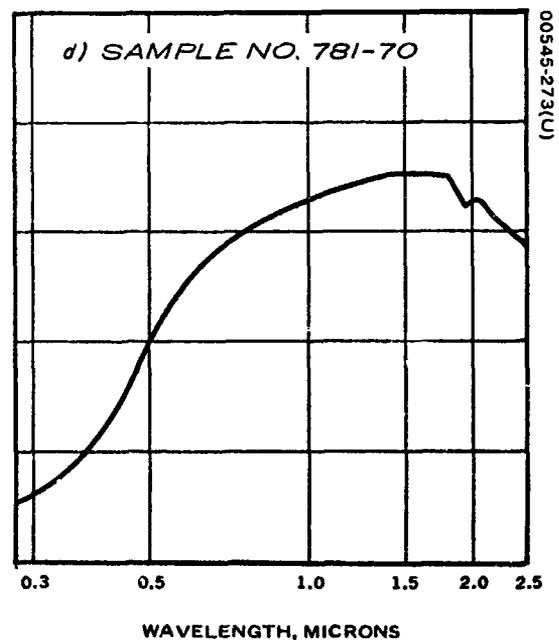
Figure J-15. Spectral Reflectance Versus Wavelength of Four Samples of White Painted Tube - 1 Atmosphere, Prior to Light Exposure

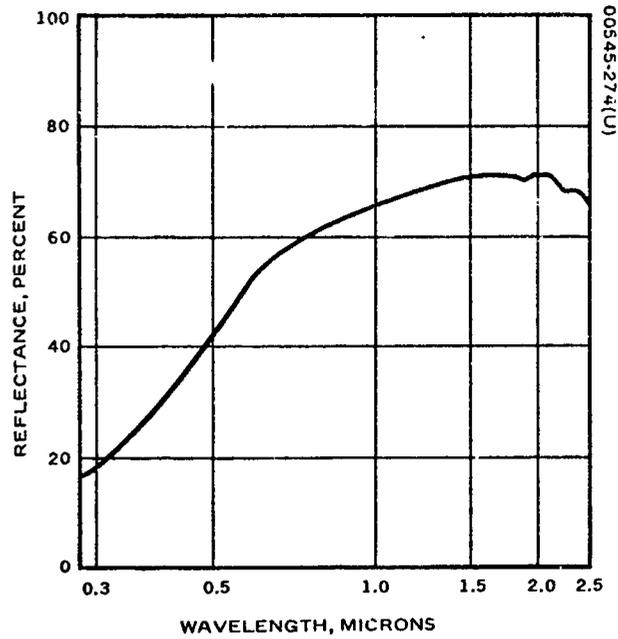
Figure J-16. Spectral Reflectance Versus Wavelength of One Sample of White Painted Tube: Sample 778-70 After 6 Days at 1 Atmosphere. Prior to Light Exposure

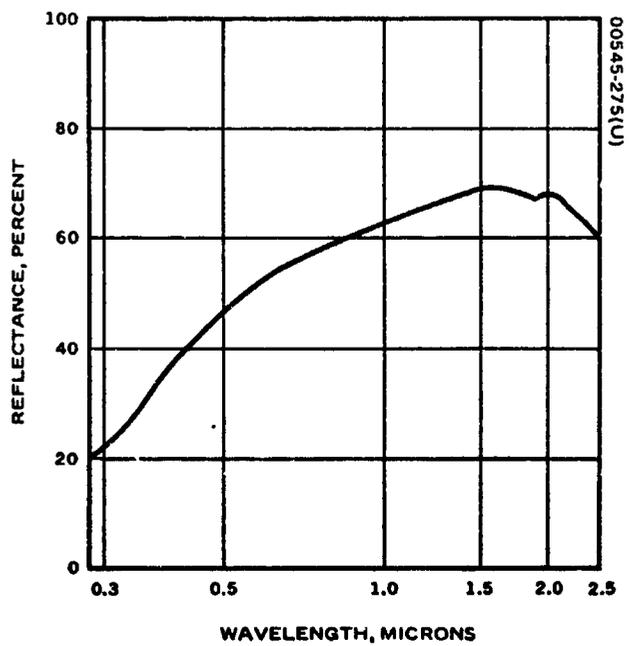
The spectral reflectance was again measured of the sample position 778-70 shown in Figure J-12. The tube was then exposed to light at position 800-70 from a xenon arc lamp through a Corning CS3-74 yellow filter. This filter removed all illuminating wavelengths less than 0.4 micron. The irradiance for the 48 hour period was 214 mW/cm^2 . The surface of the sample tube closest to the irradiating source (Figure J-12) was halfway between two of the positions which had previously been measured. Following the 48 hour exposure spectral reflectance measurements were again made at the four positions previously measured. A measurement was also made at the surface closest to the irradiating source (sample position 800-70 on Figure J-12).

Figure J-17. Spectral Reflectance Versus Wavelength of a Different Sample of White Painted Tube: Sample 800-70 in Figure J-12 After 48 Hours Exposure to Light at 1 Atmosphere

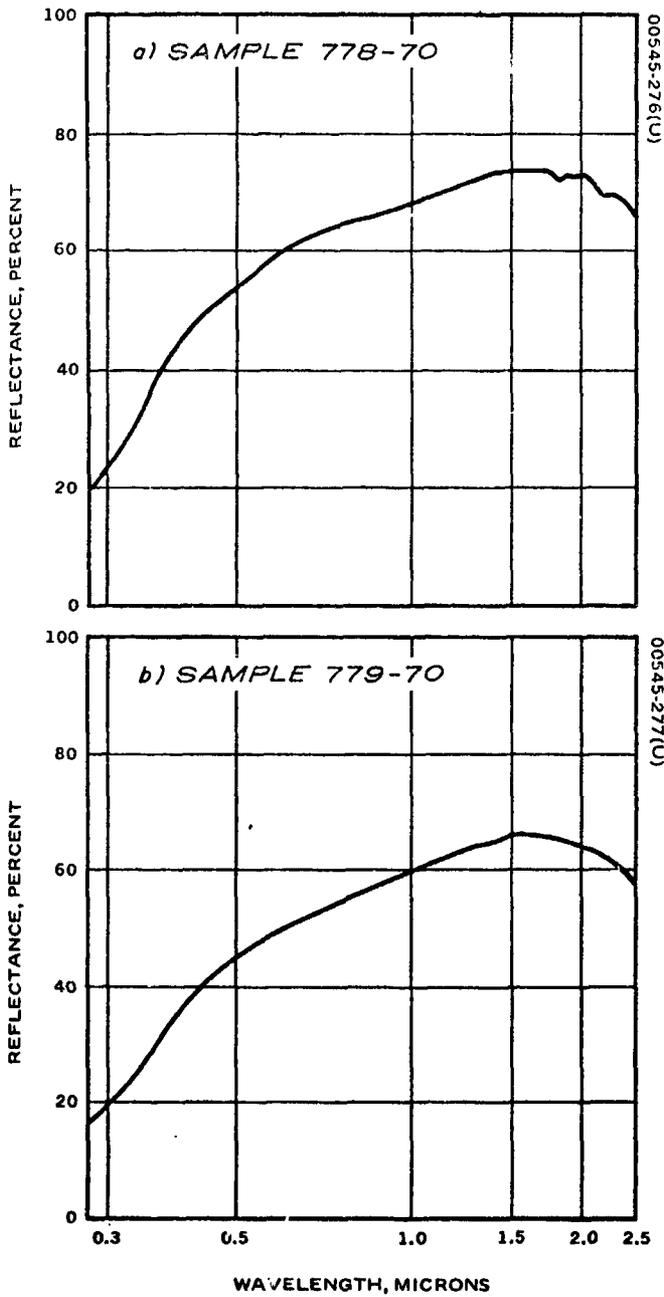
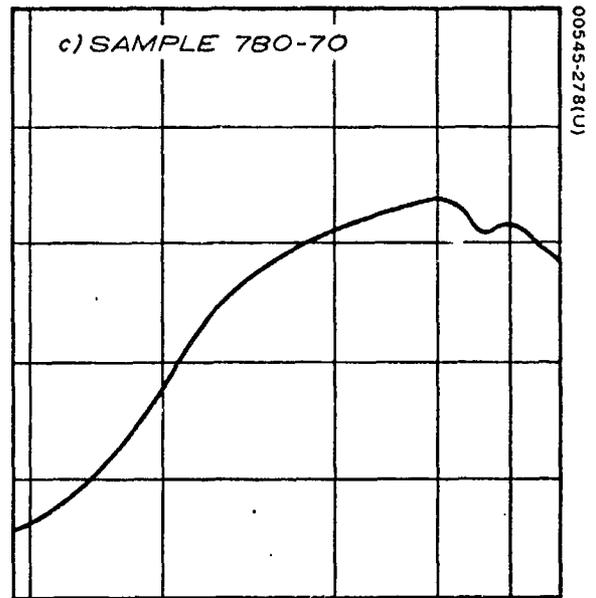
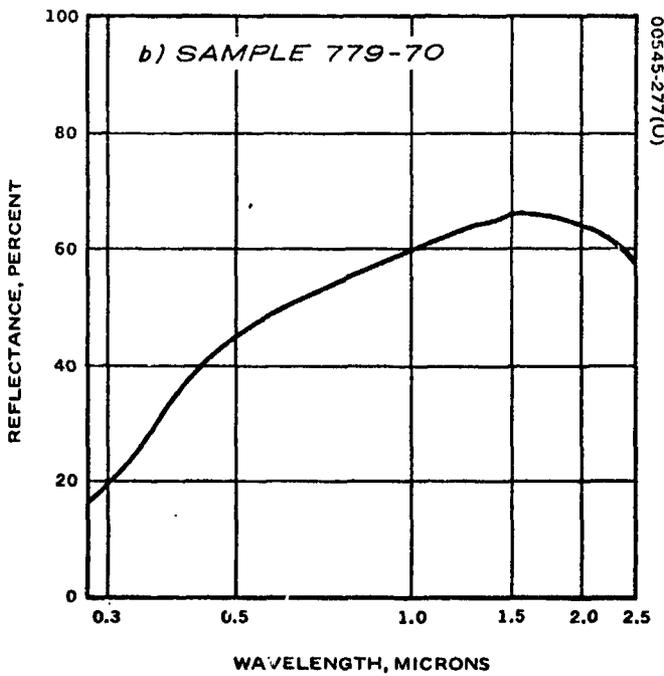
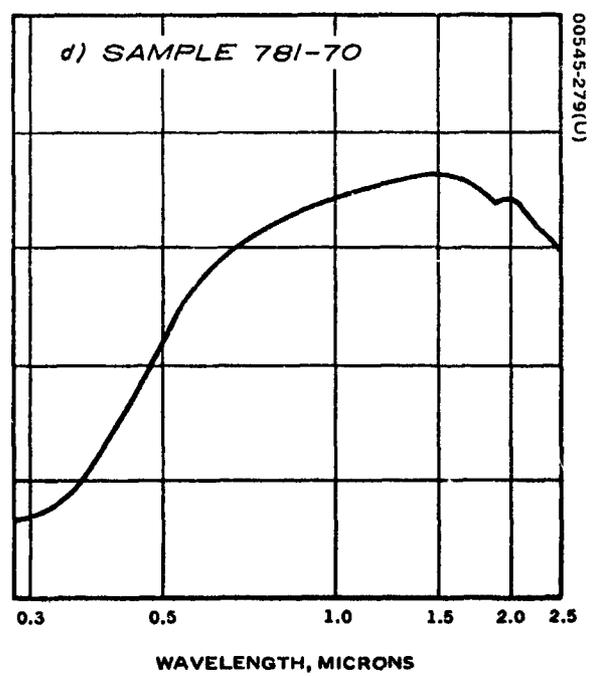
Figure J-18. Spectral Reflectance Versus Wavelength of Four Samples of White Painted Tube After 48 Hours Exposure to Light at 1 Atmosphere

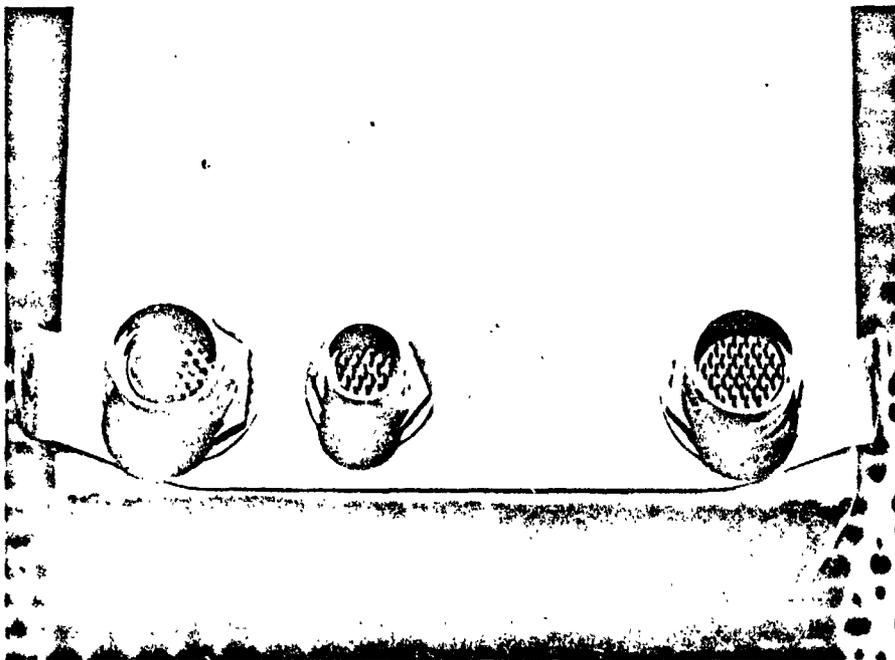
The bracket shown in Figure J-19* used to attach the TV camera cables to the lower shroud was removed from the camera at the LRL on 6 January 1970. It was wrapped in teflon FEP film and stored in the dark. In May 1970, the bracket was removed from the dark for examination. A large disparity was found in the color of the bracket and that of the lower shroud of the camera. When the bracket was removed initially, the surface of the camera and bracket were a similar brown tone. In May, the shroud was found to be much lighter, with the bracket appearing to be the same color as it was upon the first viewing of the Surveyor III hardware in January 1970. This difference in color is shown in Figure J-20.*

Figure J-19. Lower Shroud of Surveyor III Camera With Attached Cable Bracket Upon Return From Moon (NASA Photo S-70-21142)

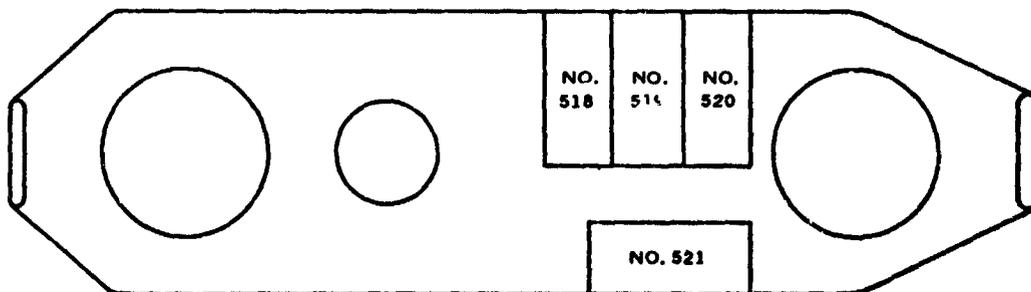
Figure J-21. Location of Samples Cut From Cable Bracket

The four test coupons were cut from the bracket, as shown in Figure J-21. Each sample was 1 by 2 cm. The spectral reflectance of these four coupons was measured. One sample, 518 in Figure J-21, was examined with a scanning electron microscope for the presence of lunar soil. Lunar material could not be distinguished from the paint. This was due to the charge buildup in the paint and lunar soil. All samples were then stored in the dark for 3-1/2 months, after which the spectral reflectance was remeasured. The original measurements of spectral reflectance versus wavelength conducted in May 1970 on one of the above samples, 518 mentioned above, are plotted in Figure J-22. Results obtained 3-1/2 months later in August 1970 showed no appreciable change. Results of spectral
